**ANDERSON BROTHERS PROPERTY
CSM Site Summary****ANDERSON BROTHERS PROPERTY**

Oregon DEQ ECSI #: 970

5275 & 5315 NW St. Helens Road

Date of Last Revision: May 31, 2005

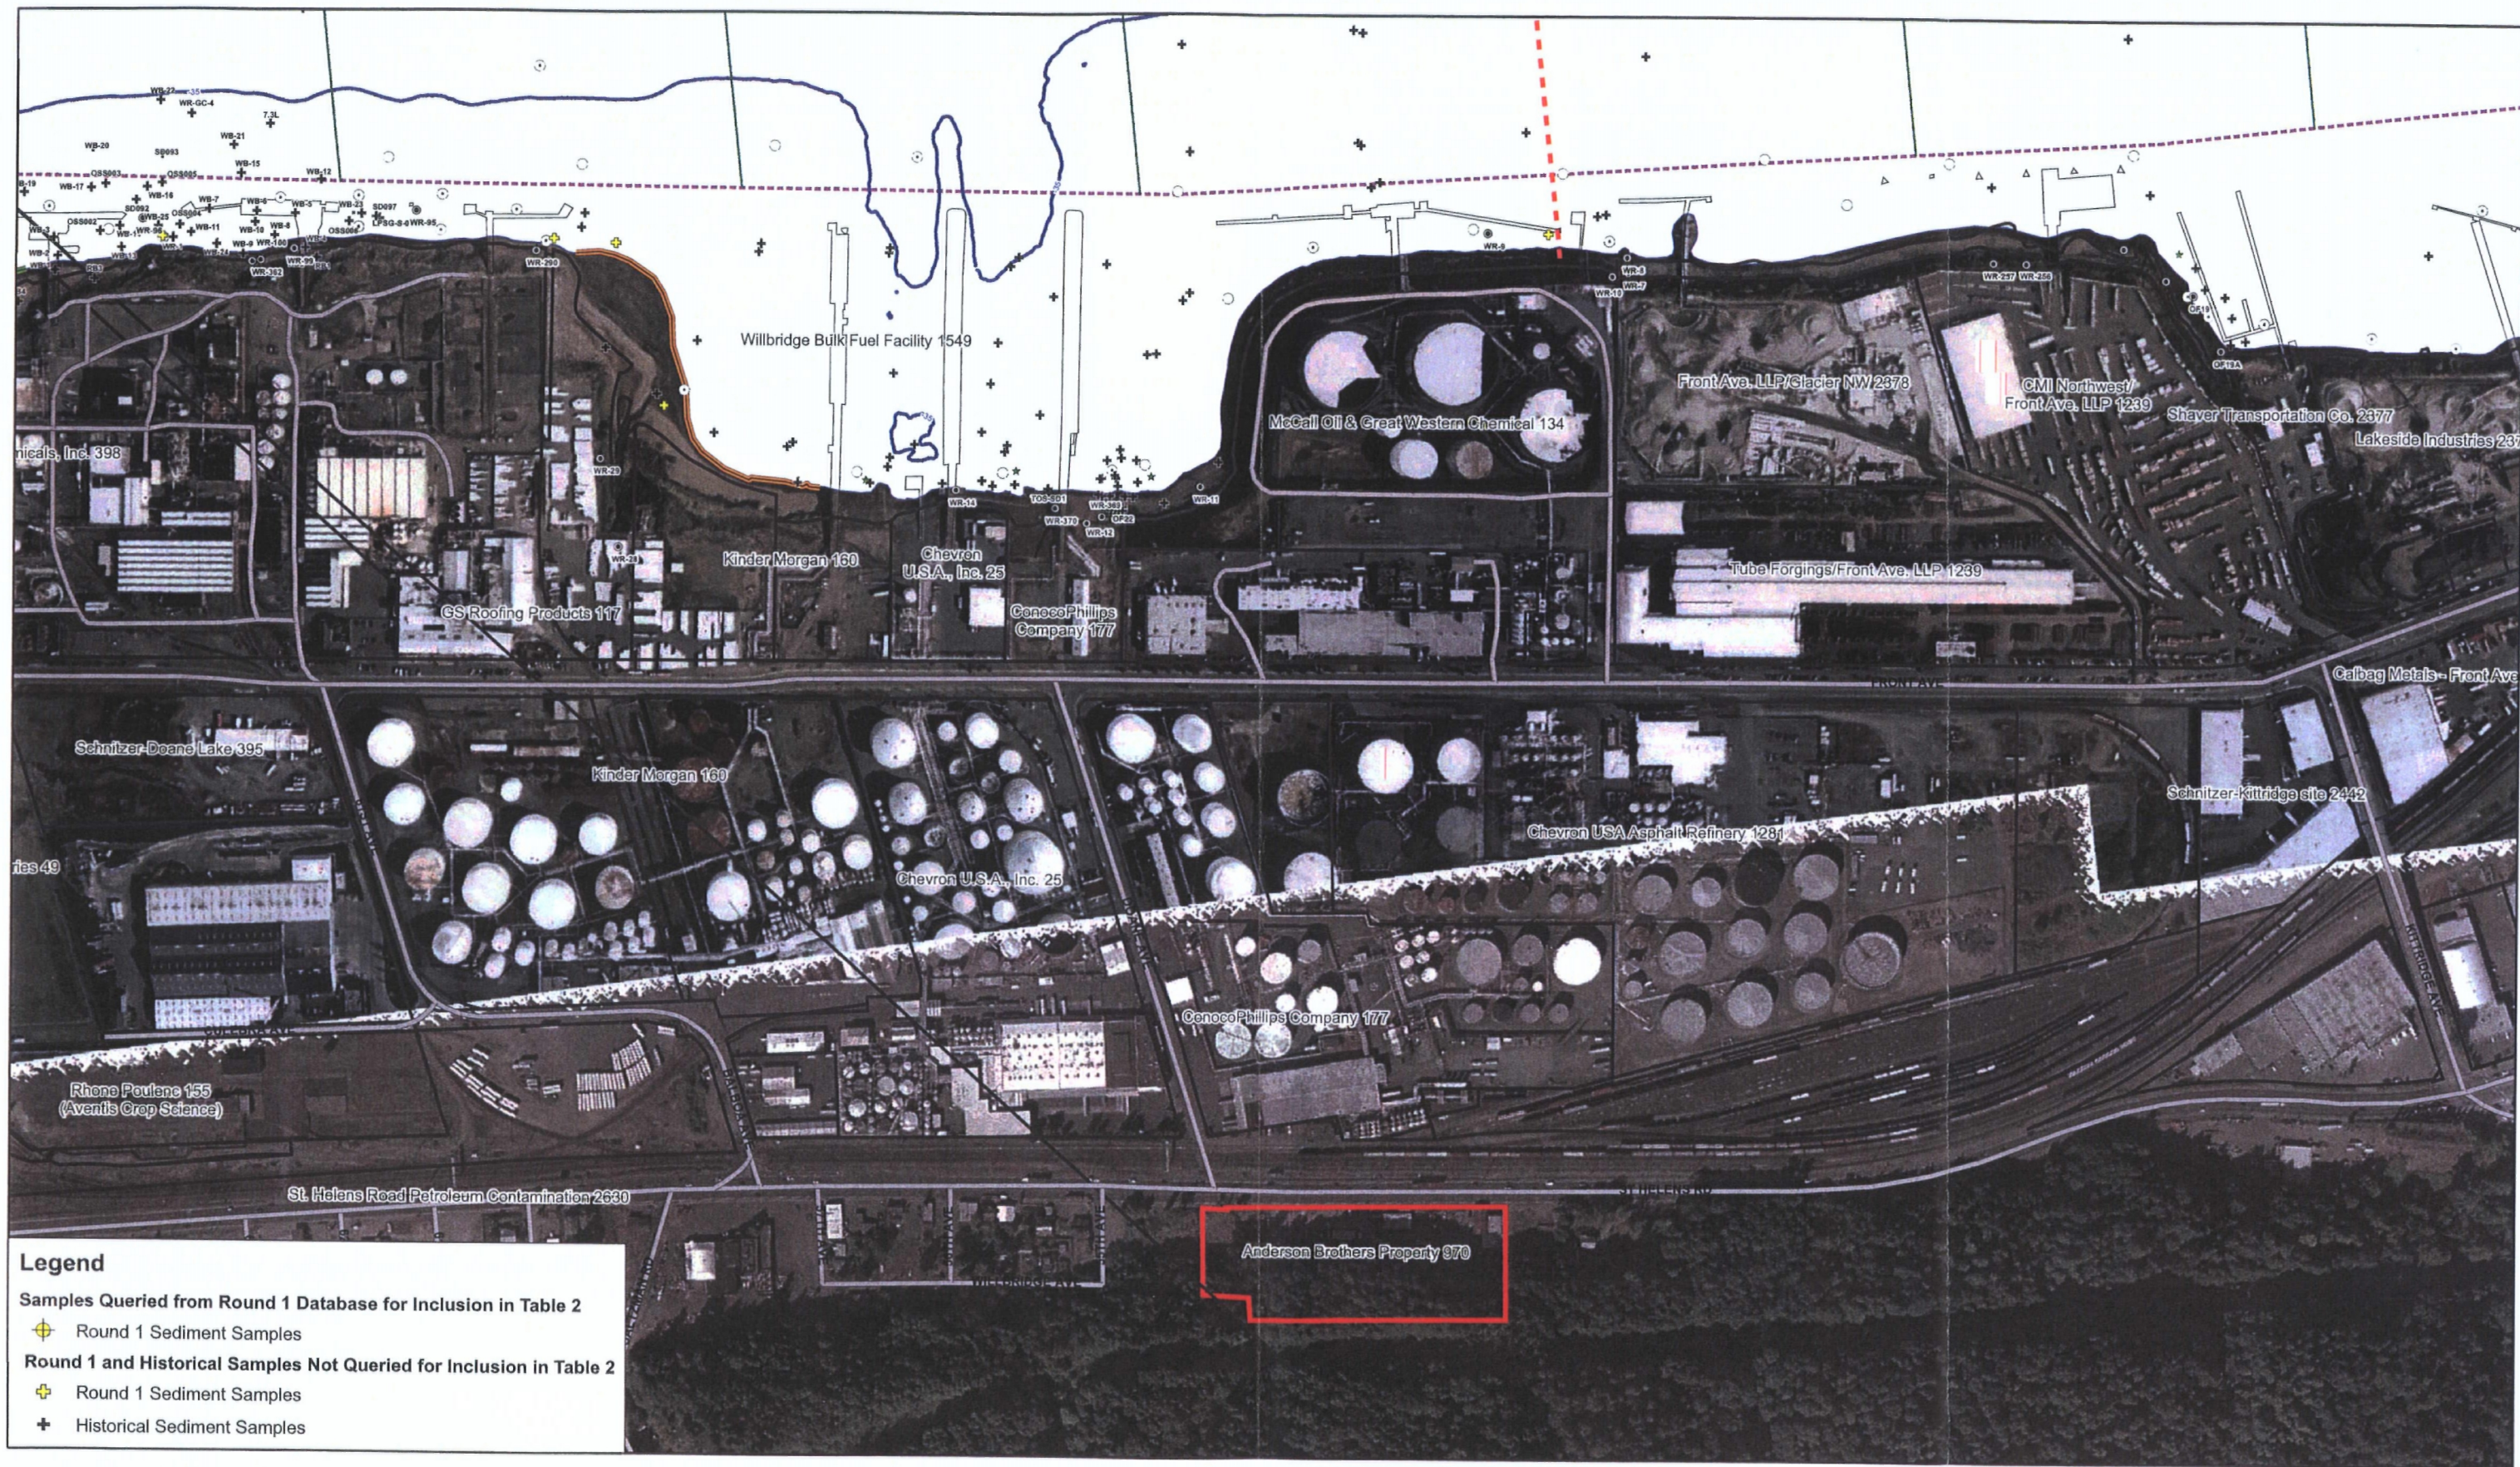
Figure 1. Site Features

The Anderson Brothers' property is located approximately 0.5 mile south of the Willamette River at RM 8 (Figure 1). The property is slightly less than 4 acres in size and is located at the base of the undeveloped Portland Hills. There is a paucity of information on this site in DEQ files. Aerial photos reviewed by Integral Consulting, Inc. show that over half of the site is covered with Douglas-fir, western hemlock, and grand fir trees, with 2-3 buildings and piles of miscellaneous materials. One concrete building and two metal fabricated buildings were noted on the property in January 2005 (Sund 2005, pers. comm.). All three buildings were full of miscellaneous debris and trash. Construction trucks, vans, boom trucks, and other vehicles were parked in two separate graveled parking lots. Barb-wired fencing surrounded multiple, large rolls of cable in one of the parking lots (Sund 2005, pers. comm.).
